# Uncommon fractures of Gates Glidden bur

**Keywords:** Endodontics. Root canal therapy. Fracture zone.

**How to cite this article:** Victorino FR, Fernandes R. Uncommon fractures of Gates Glidden bur. *Dental Press Endod.* 2012 Jan-Mar;2(1):42-5.

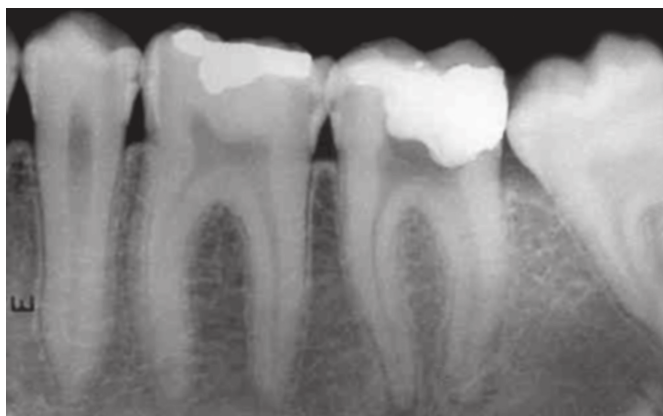
The patient of male gender, 21 years old and referred by a general practitioner to perform endodontic treatment of tooth #37. Clinical and radiographic examination (Fig 1) determined the diagnosis of pulp necrosis.

Figure 1. Initial X-ray.

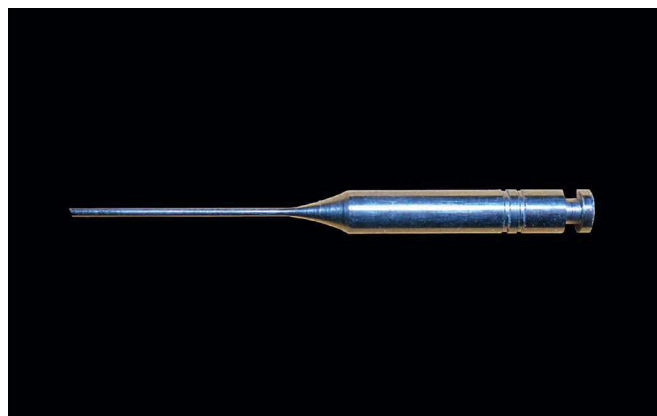
After the rubber dam, cavity access and exploitation of the root canal with a K-type hand file #10 (Maillefer, Ballaigues, Switzerland) using a #2 Gates Glidden bur (Maillefer, Ballaigues, Switzerland) in the mesial buccal canal, a slight click and a sudden change of direction were perceived. By removing the bur from the root canal, its tip break was observed (Fig 2). A radiographic evaluation showed the fractured bur tip retained in the canal middle third (Fig 3).

Figure 2. Fractured Gates Glidden bur.

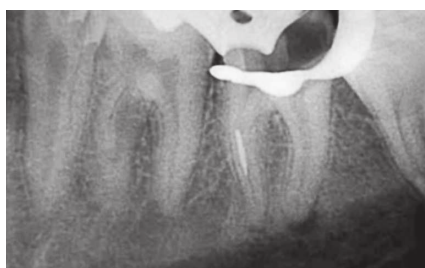
Figure 3. Fractured bur tip, retained in the canal middle third.

occurrence of instruments fracture, it is always necessary to respect the instruments' kinematics of use, avoiding sudden movements inside root canal. The instrument fracture caused by fatigue presents high occurrence rates and could be avoided by professionals.<sup>4,8</sup> In this case, it was evidenced that the fracture resulted from fatigue and torsion of the instrument, as noted in the scanning electron microscopy (Fig 7). It should be also noted that there was no previous preparation of the cervical third, which became another stressing factor on the bur, as seen in Figure 3.

Initially, we tried to remove the bur tip with a K type file #10 followed by Headstroem files, but without success. Using a #10 K file it was possible to pass by the fragment. Then, we decided by using a CV-Dent 1000 (CVD Vale, São José dos Campos, Brazil) ultrasound, with the T0S-E1 tip, indicated for removal of fractured instruments. Before using them, an anti-wear curve was developed with a LA Axess #35 (SybronEndo, Orange, CA, USA) bur, improving the access to mesiobuccal canal. The ultrasound power was set at 50%, at endodontics function, working around the bur tip for a few minutes. Developing a radiographic confirmation of the working length, it was possible observe the fragment removal (Fig 4).

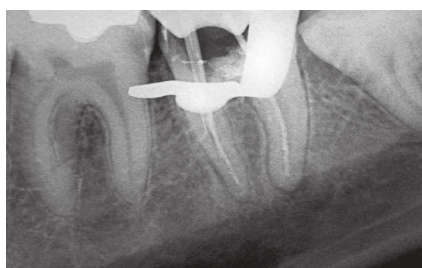
Figure 4. Working length.

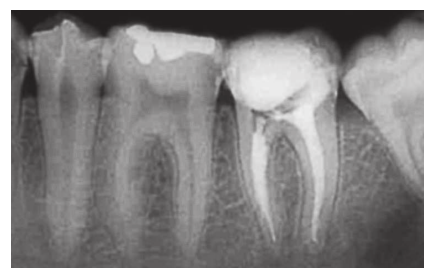
Figure 5. Root canal obturation.

The root canal obturation was performed with Sealer 26® (Dentsply, Petrópolis-RJ, Brazil) and gutta percha cones by Tagger hybrid technique (Fig 5). The X-ray control was performed after one year (Fig 6).

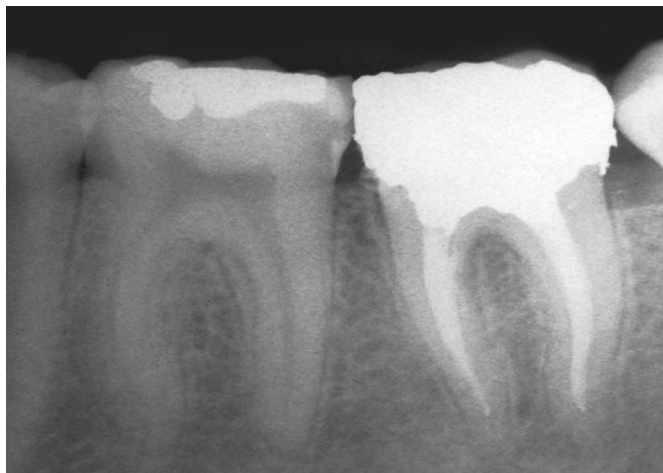
Figure 6. Control X-ray after 1 year.

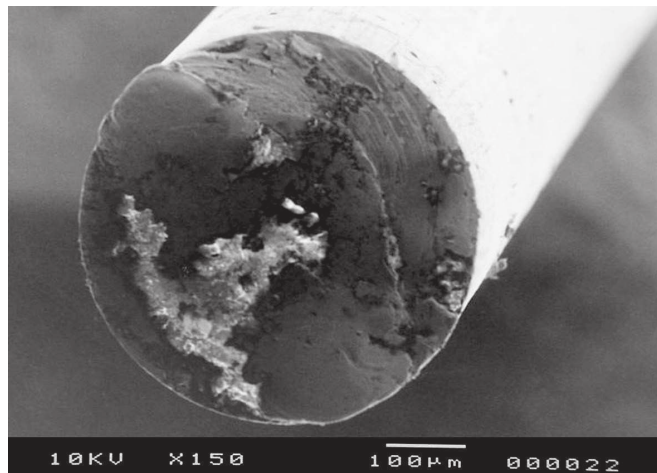
Scanning electron microscopy with an increase of 150X was performed on the fractured bur (Fig 7).

Figure 7. Scanning electron microscopy (150x).

The fact of Gates Glidden bur to fracture close to its active portion, an unusual location, is due to

tension generated in the bur, within the canal.<sup>6</sup> This bur is constantly submitted to torsion and bending, which may cause normal and shearing stresses, which are concentrated in a region where fractures usually occur.<sup>1</sup> In most cases, the instruments fracture is due to incorrect or excessive use.<sup>8</sup> In order to avoid the
