Use of technology and calcium silicate cement in the resolution of endodontic retreatment complications: Case report

How to cite: Silva EM, Alcalde MP, Vivan RR, Pomini M, Duarte MAH. Use of technology and calcium silicate cement in the resolution of endodontic retreatment complications: Case report. *Dental Press Endod.* 2020 May-Aug;10(2):86-93. DOI: <https://doi.org/10.14436/2358-2545.10.2.086-093.oar>

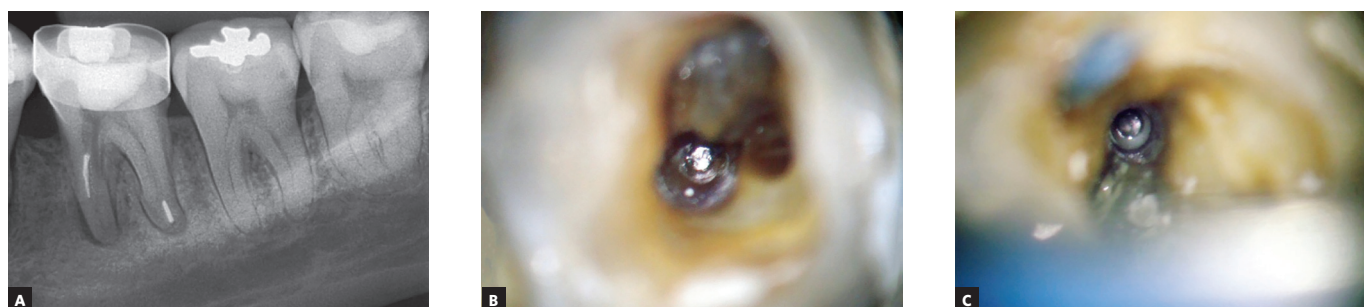
The patient was aware of the presence of the fragment in the root canal, complained of painful tenderness in the affected tooth region and reported a history of edema. A periapical radiograph of the tooth 36 was performed and it was observed that the tooth had not only one, but two separate instruments (Fig 1A). The fragment reported by the indicator was in the mesial root, between the cervical and middle thirds, and the other metallic fragment in the apical region of the distal root. Initially, it was not possible to identify the type of fractured instrument; however, it was thought to be a conical drill fragment. In addition, it was possible to radiographically notice excessive dentin wear on the mesial root near the furcation region and the presence of periapical lesion on the mesial root.

At the first visit, the patient was anesthetized by lower alveolar nerve block (MEPIADRE 100, Nova DFL, Taquara, Rio de Janeiro, Brazil), rubber dam isolation and removal of the temporary filling material was done. Pulp chamber observation was performed using an operating microscope (DF Vasconcelos MC1232, São Paulo, Brazil). Then, the presence of fractured instruments was detected in the mesio-buccal canal (Fig 1B) and in the distal canal (Fig 1C).

Figure 1. Preoperative: **A)** Initial periapical radiograph of the case, in which it is possible to observe fragments both mesial and distal roots and the presence of radiolucency in the periapical region. **B)** Microscopic image of the fragment stuck in the mesiobuccal canal. **C)** Microscopic image of the fragment stuck in the distal canal.

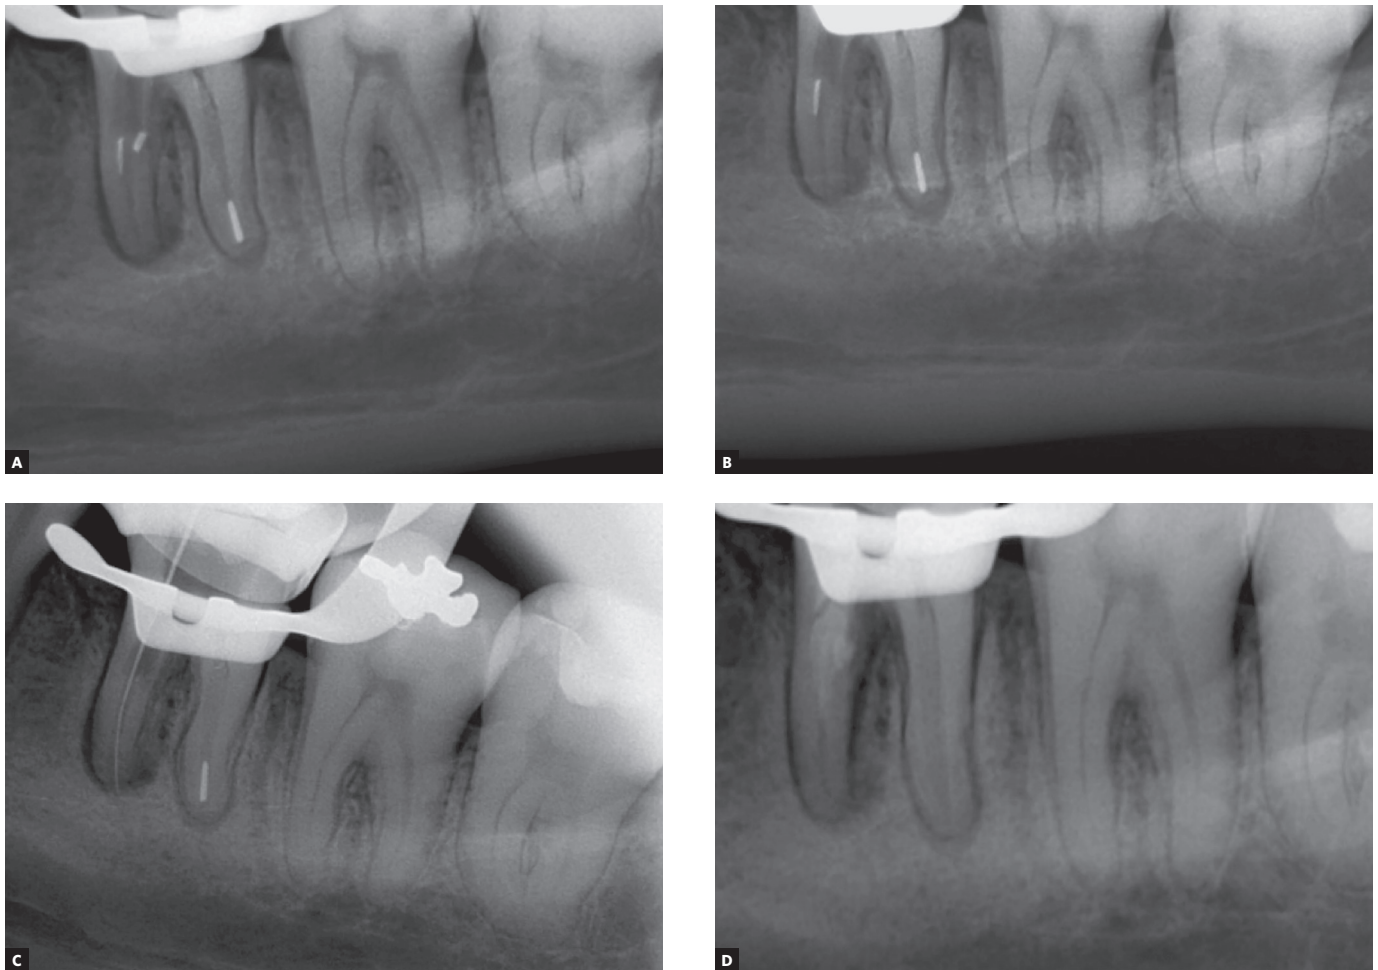
During the removal procedure, a second fracture of the fragment being removed occurred, which was visualized on the periapical radiograph (Fig 3A). Additionally, a perforation could be observed in the area. Once the secondary fragment was removed by vigorous saline irrigation, the slit was deepened parallel to the remainder broken file using the TFRK-6 instrument (Fig 2C). The process of removing the fragment in the mesiobuccal canal was continued. This

Figure 3. Transoperative: **A)** Periapical radiograph of lower left first molar, in which it is possible to visualize the secondary fragment. **B)** Periapical radiograph of lower left first molar after removal of the secondary fragment. **C)** Periapical radiograph of lower left first molar showing that the canal path was unblocked. **D)** Periapical radiograph of lower left first molar after insertion of dense calcium hydroxide paste in the mesiobuccal canal.

During the process of removing the mesiobuccal canal fragment, a secondary fracture occurred, a fact that further increased the complexity of the case. This occurrence can be explained by some factors: 1) lack of the creation of a deeper space with the micro spoon inserts between the fragment and the canal wall - this space or semicircular rift must have at least 1/3 of the total length of the fragment so that it can be more easily displaced by ultrasonic activa-

step was performed using a TFRK-S (Fig 2D) straight ultrasonic tip driven with lower power. Following the correct protocol, the fragment was removed, and the canal path was found (Fig 3C).

The next step was the removal of the metallic fragment present in the distal root canal. For this, a set of 1st series K files (Dentsply Maillefer, Ballaigues, Switzerland) was used under constant irrigation and aspiration to create a lateral space to the fragment and the inner wall of the canal. This was facilitated by the elliptical anatomy of the distal canal itself. Then, TFRK-S ultrasonic tip was used between the instrument and the canal wall, performing short axial movements, allowing the fragment to be removed (Fig 3D).

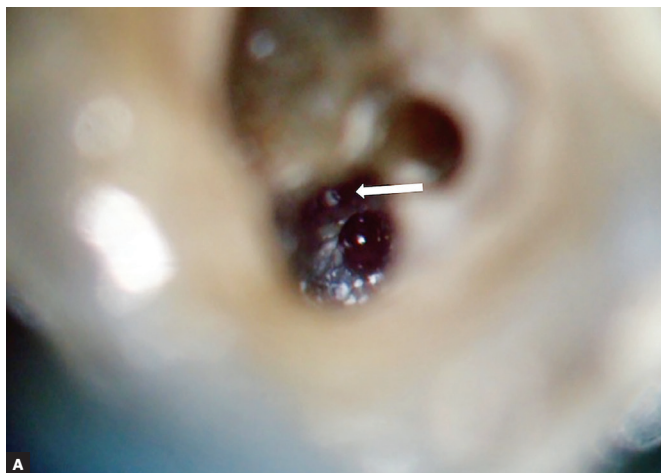
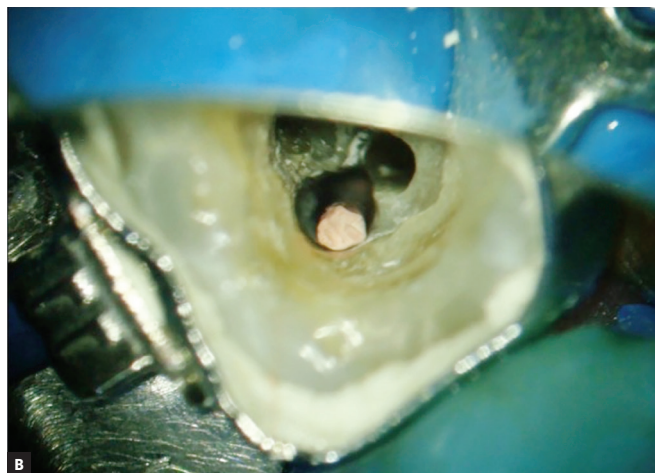
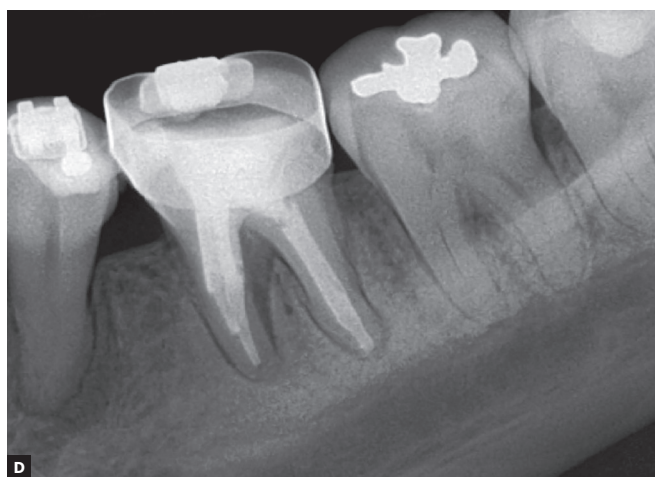
Figure 4. Perforation sealing: **A)** Microscopic image of the perforation located at the mesial root. **B)** Gutta-percha cone inserted into the buccal middle canal to avoid path obliteration by MTA. **C)** Image of sealed perforation after insertion of HP MTA. **D)** Periapical radiograph of lower left first molar after root canal filling.

After 14 days, the patient returned for sealing of the mesiobuccal canal perforation. The material of choice was MTA Repair HP (Angelus, Londrina, Paraná, Brazil). The medication was removed, keep-

ing only a small portion inside the perforation (Fig 4A), so that it could serve as a support for MTA⁹, thus avoiding material extrusion. In order to prevent the MTA from being accidentally inserted into the mesiobuccal canal, it was provisionally obliterated with a gutta-percha cone (Fig 4B).

After manipulation of the MTA according to the manufacturer's instructions, it was taken and inserted into the perforation area using a MAP System apical microapplication system (Produits Dentaires SA, Vevey, Switzerland) and accommodated in the perforation area using a properly sized plugger. After this, the gutta-percha cone was removed from the mesiobuccal canal. At this point (Fig 4C), it could be observed that

the perforation was properly filled by the repair material. A sterile sponge moistened with distilled water was applied over the MTA so that it could have its prey consolidated. At the end of this session, temporary sealing was performed with Ionoseal glass ionomer material (Voco, Porto Alegre, Rio Grande do Sul, Brazil).

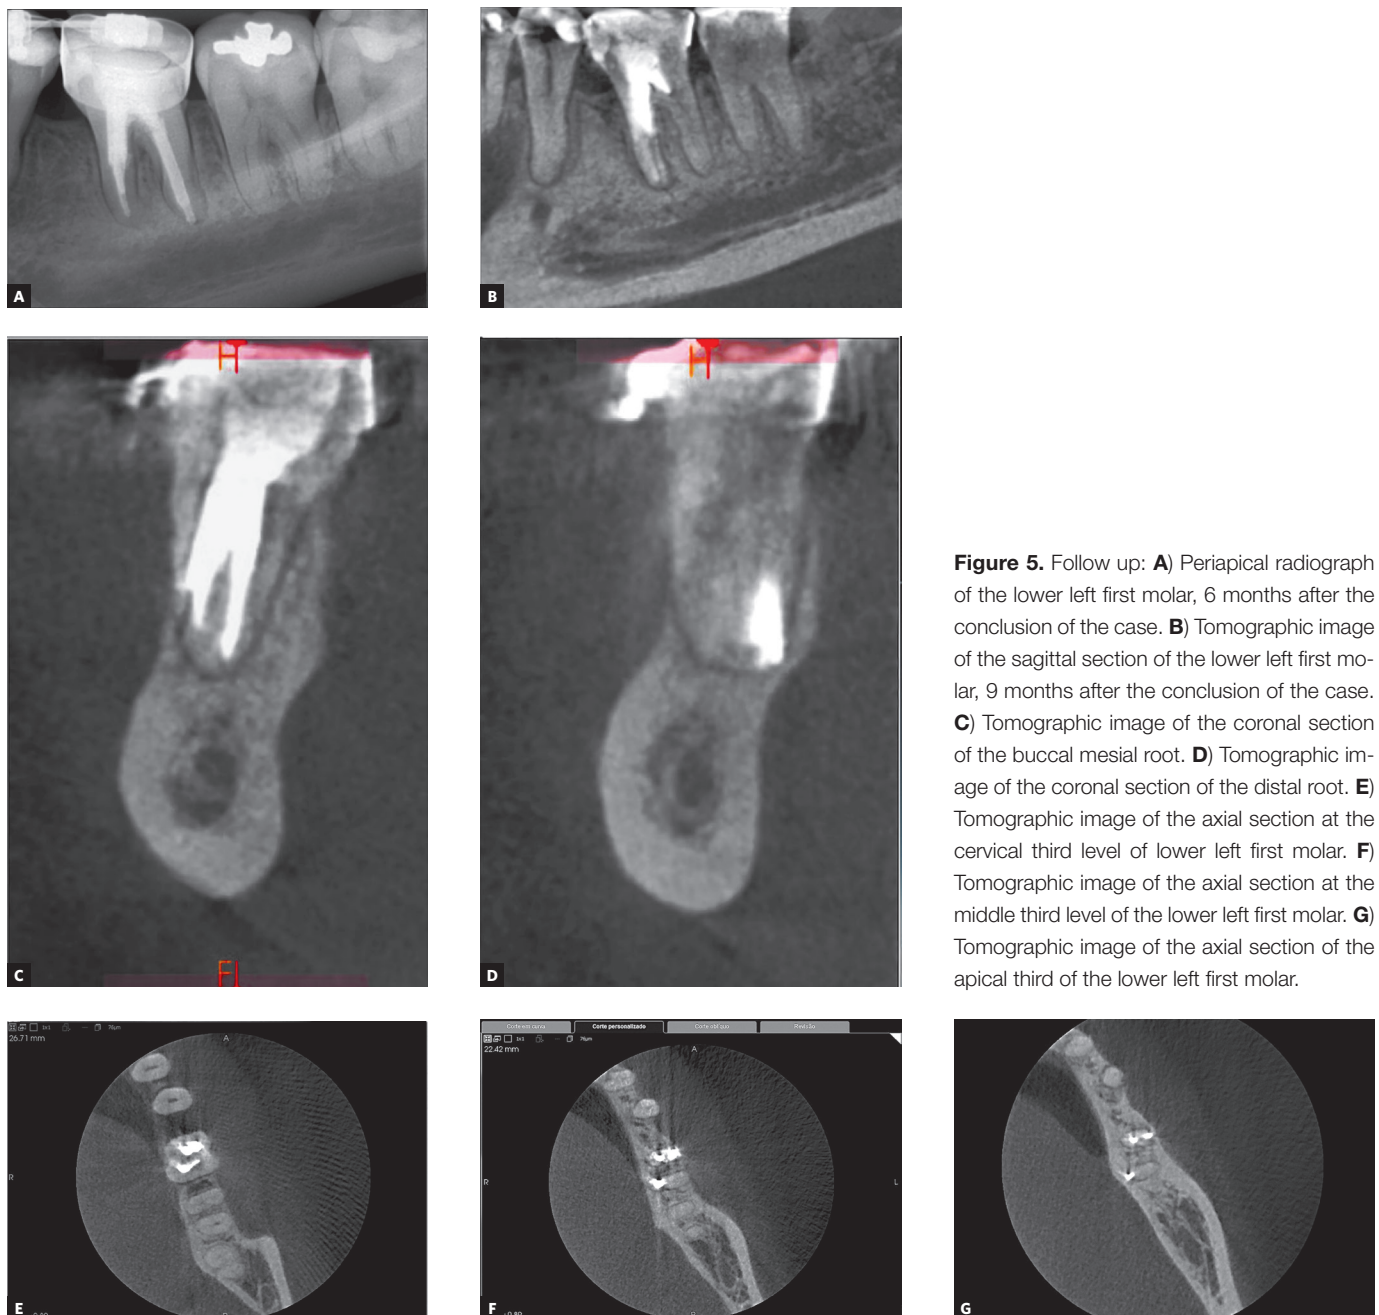
The patient was clinically and radiographically controlled for 6 months, within this period of time, it was noticed the normality of the periapical tissues, remission of the periapical lesion in the mesial root (Fig 5A), and absence of symptoms. After this time, a CBCT exam was requested for a more accurate observation of the of periradicular tissues, especially in the perforation region, as well as a better analysis of the presence or absence of lesions. The tomographic images in the

sagittal (Fig 5B) and coronal (Fig 5C) sections showed normality of the periapical tissues and integrity of the bone tissue in the furcation region, where the perforation was located. Finally, in the axial cuts of the cervical, middle and apical thirds (Figs 5 D, E, F), respectively, it was possible to observe, especially in the cervical section, the integrity of the bone tissue in the region where the root perforation was located. , proving the success of the procedure proposed to the patient.

Figure 5. Follow up: **A)** Periapical radiograph of the lower left first molar, 6 months after the conclusion of the case. **B)** Tomographic image of the sagittal section of the lower left first molar, 9 months after the conclusion of the case. **C)** Tomographic image of the coronal section of the buccal mesial root. **D)** Tomographic image of the coronal section of the distal root. **E)** Tomographic image of the axial section at the cervical third level of lower left first molar. **F)** Tomographic image of the axial section at the middle third level of the lower left first molar. **G)** Tomographic image of the axial section of the apical third of the lower left first molar.
