# Clinical management of endodontic instrument fracture: report of two clinical cases

## ABSTRACT

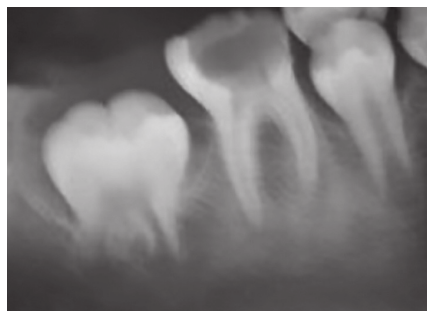
**Figure 1.** Initial radiography of tooth #46 exhibiting wide coronary destruction and caries lesion with endodontic involvement.

A 10-year-old healthy girl patient sought the endodontic clinic together with her mother to undergo a clinical evaluation. During the clinical assessment, it was observed heavy amount of plaque, and the radiographic examination revealed several teeth with caries lesions. One of these tooth (#46) presented wide coronary destruction and a deep lesion affecting the pulp (Fig 1). Pain was not reported. A treatment plan was elaborated, and the following procedures were sequentially organized to be performed: restoration of the teeth with caries lesions, oral hygiene instruction, endodontic treatment, and prosthetic rehabilitation of tooth #46.

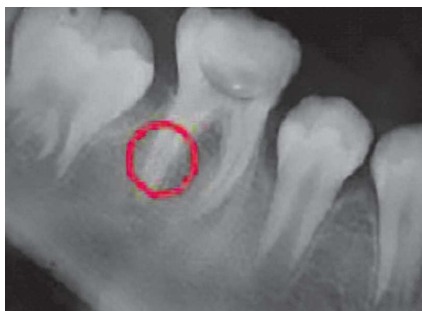
**Figure 2.** Radiographic examination of tooth #46 showing the fragment of the fractured Lentulo spiral ( $\approx 3\text{mm}$ ).

On the first clinical session of the endodontic treatment, four root canals underwent chemical-mechanical preparation. In the sequence, it was decided to fill the canals with calcium hydroxide paste using a Lentulo spiral (Dentsply-Maillefer, Ballaigues, Switzerland). However, the clinician was not aware of the rotation direction of the instrument, and used the motor in an anti-clockwise direction.

Consequently, the Lentulo spiral touched the root canal walls and got stuck onto the dentin, which caused the instrument fracture within the disto-lingual canal (Fig 2).

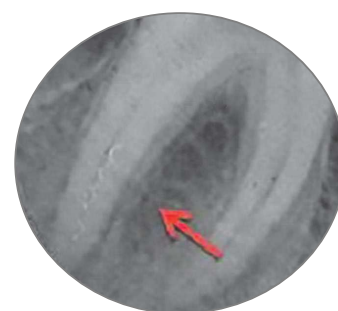
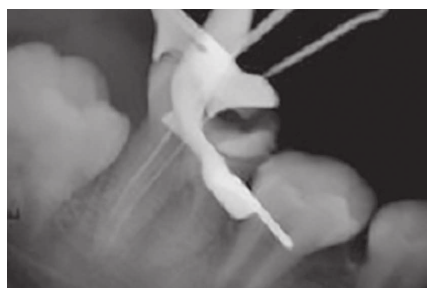
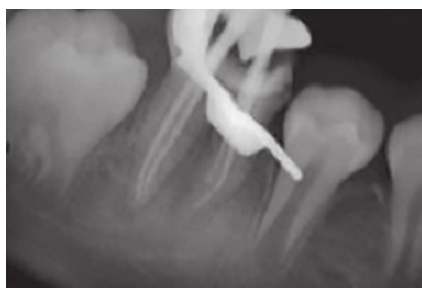
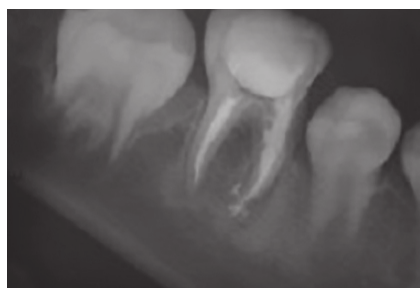
**Figure 3.** Radiographic examination sequence showing the steps of the endodontic treatment and the final aspect of the therapy.

Several attempts of removing the fragment by traction were performed using Hedstroem instruments (Dentsply-Maillefer). Due to the level of

difficulty for the removal of the fragment, it was decided to leave it within the canal, since it was possible to bypass it, and complete the instrumentation until the apex foramen. Then, the obturation of the root canals was performed using the hybrid Tagger's technique (Fig 3) achieving the control of the apical foramen sealing.

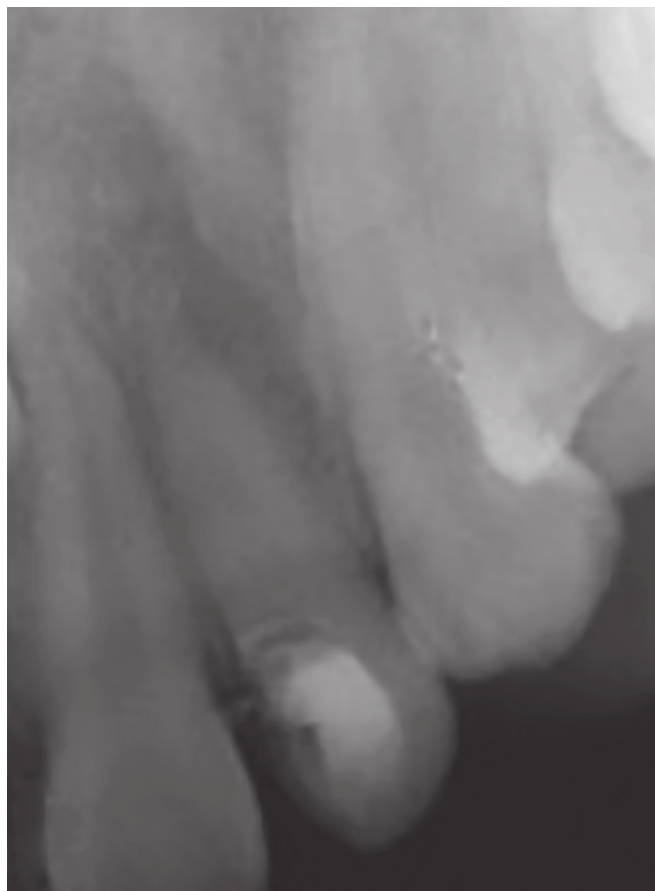
**Figure 4.** Initial radiographic examination of tooth #22.

An 18-year-old healthy women patient sought the endodontic clinic complaining about toothache. The clinical and radiographic examinations revealed that tooth #22 was seriously compromised, and it was diagnosed as the pain causative factor (Fig 4). The access cavity was performed, the pulp tissue was removed, and the root canal underwent mechanical instrumentation. Then, it was decided to fill the root canal with calcium hydroxide using a Lentulo spiral. Similarly to the previously described case, the clinician was not aware of the rotation direction of the motor, which resulted in the fracture of the Lentulo spiral (Fig 5). Differently from Case 1, the separated fragment was 10 mm long, and was located from apex foramen to the cervical third of the tooth. Since the fragment was stuck within a tooth with a linear root canal, it was decided to attempt the removal. The attempt to remove the fractured instrument by traction was unsuccessful. Thus, it was adopted a method similar to what Masserann<sup>16</sup> described in 1971. To perform this method a hypodermic needle (25 x 0,70; BD do Brasil, Curitiba, Brazil) was used, and it was externally adapted to the fragment.

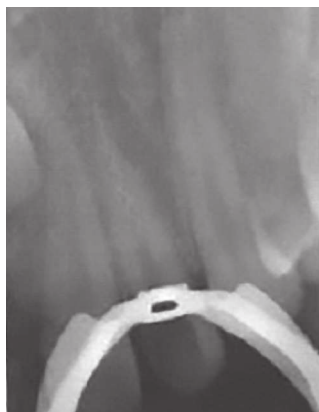
**Figure 5.** Radiographic examination of tooth 22 exhibiting the fragment of the fractured Lentulo spiral.

Hulsmann and Schinkel<sup>21</sup> demonstrated that grater the fragment is, the procedure of removal was easier. These authors also affirmed that it is hard to remove fragments located apically to the curvature of the root canals. The second clinical case reported in this investigation described a 10-mm fractured instrument stuck into the canal of a maxillary incisor. The characteristics of the tooth influenced the decision of removing the fragment. As the clinician did not have any specific device to remove the instrument, it was adopted an alternative technique. Thus, using a hypodermic needle and cyanoacrylate adhesive it was possible to successfully remove the instrument from the canal.

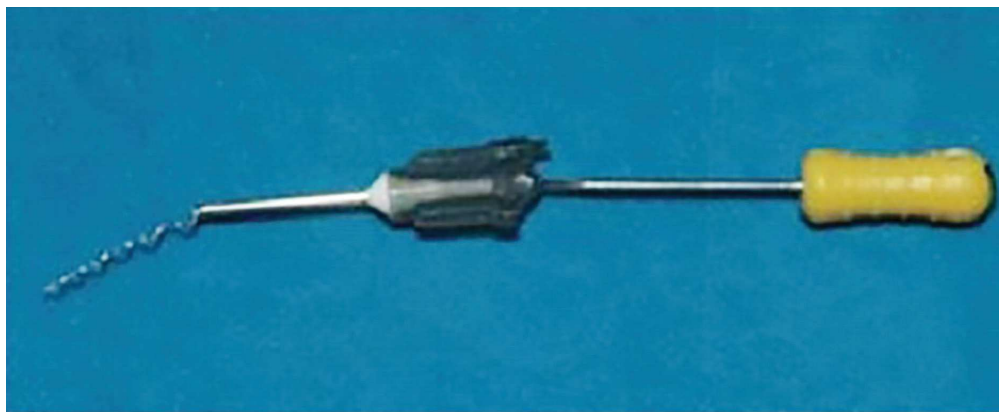
**Figure 6.** The clinical aspect of the same fragment after its removal.

When the needle was adapted to the fragment, cyanoacrylate based adhesive (Super Bonder; Loctite do Brasil, São Paulo, Brazil) was used as a manner to fix the needle to the fragment. Due to the diameter of the fractured Lentulo spiral, a manual endodontic #20 K-file was also inserted into the canal locking the fragment to the inner wall of the needle. A clockwise

rotation was performed resulting in the complete removal of the fractured instrument (Fig 6). Finally, the obturation of the root canal was performed using the hybrid Tagger's technique (Fig 7).

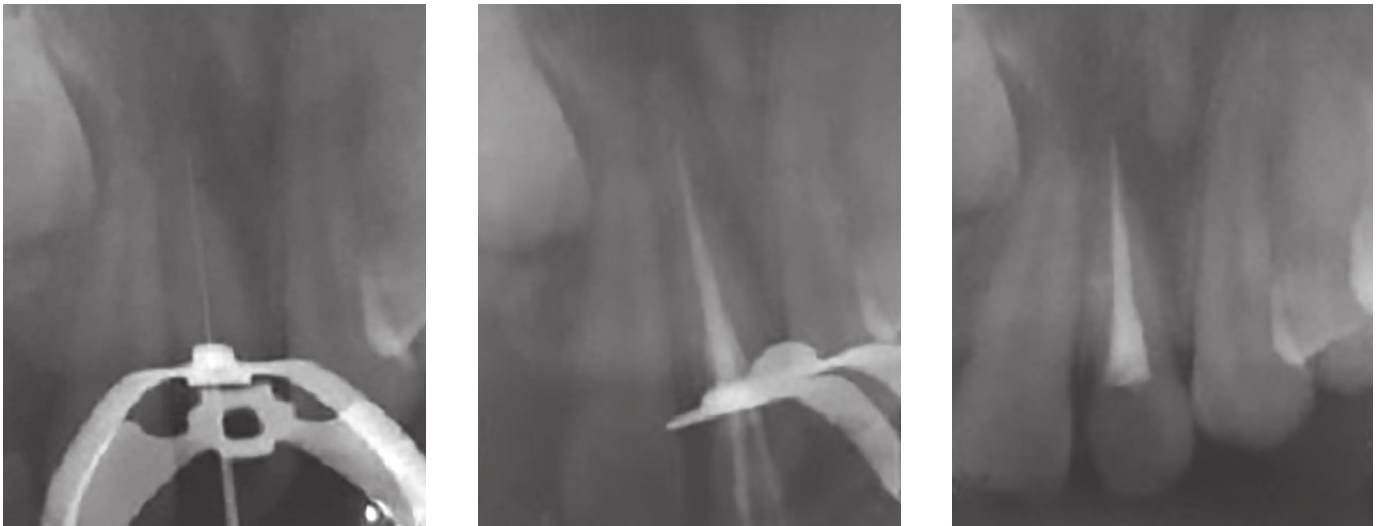
**Figure 7.** Radiographic examination sequence showing the steps of the endodontic treatment and the final aspect of the therapy.
