Rehabilitation of anterior teeth with direct composite resin restorations: 3-year follow-up

ABSTRACT: **Introduction:** Fractures in anterior teeth are frequently considered as emergencies in dental practice. Crown fractures not considered complicated involve enamel and dentin and may receive different levels of treatment, such as bonding the dental element or restoring it with composite materials. **Objective:** The goal of this study was to perform aesthetic and functional rehabilitation through the use of composite resins. Three cases of patients who suffered different degrees of uncomplicated crown fractures in upper central incisors were treated with direct composite resin restorations. **Results:** Treatment with resins composite restoration of aesthetics and function was adopted in all three cases. **Conclusion:** Three years of follow-up with clinical and radiographic exams revealed successful rehabilitation of fractured teeth. **KEYWORDS:** Dental restoration, permanent. Fractures. Case report.

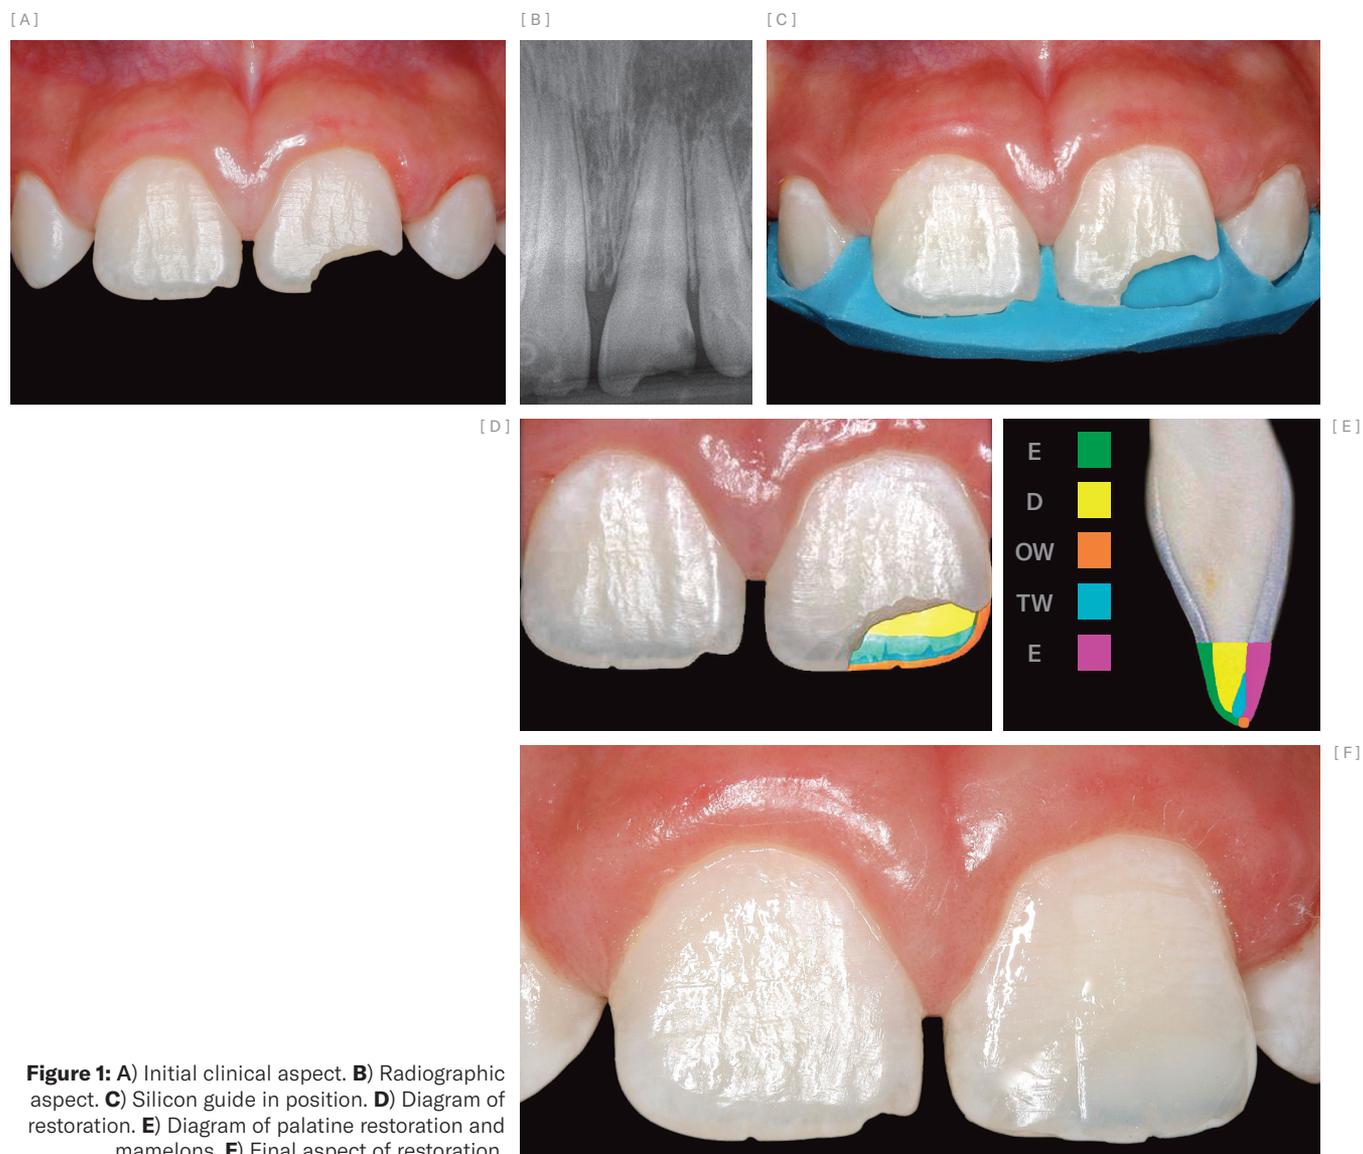
A 11-year-old male patient was presented in emergency sector at the School of Dentistry of the Federal University of Pelotas with fracture of his maxillary central incisor (teeth 21). During the anamnesis, the patient reported experiencing dental trauma at school but he did not remember the details of the accident. Clinically there was no mobility and lesions in soft tissues. The clinical and radiographic examinations also revealed a fracture confined to enamel and dentin with loss of tooth structure, but not involving the pulp (Fig 1A). The radiographic exam also showed no radiographically visible periodontal lesions or presence of alveolar bone fracture (Fig 1B).

Figure 1: A) Initial clinical aspect. B) Radiographic aspect. C) Silicon guide in position. D) Diagram of restoration. E) Diagram of palatine restoration and mamelons. F) Final aspect of restoration.

As a conservative alternative to rehabilitation, the protocol proposed was the restoration of the anterior teeth with direct composite resin. The first step was to restore the tooth 21 using a translucent white composite resin (TW Amelogen Plus, Ultradent Products, South Jordan, UT, USA) under relative isolation by the technique of natural stratification of colors, and was done freehand (without the aid of a silicone barrier) on palatine. After that, enamel white composite

resin was used in dentin and enamel (EW Amelogen Plus, Ultradent Products, South Jordan, UT, USA) and an opaque white composite resin

was used for the creation of the incisal halo (OW Amelogen Plus, Ultradent Products, South Jordan, UT, USA) (Figs. 1C-F).

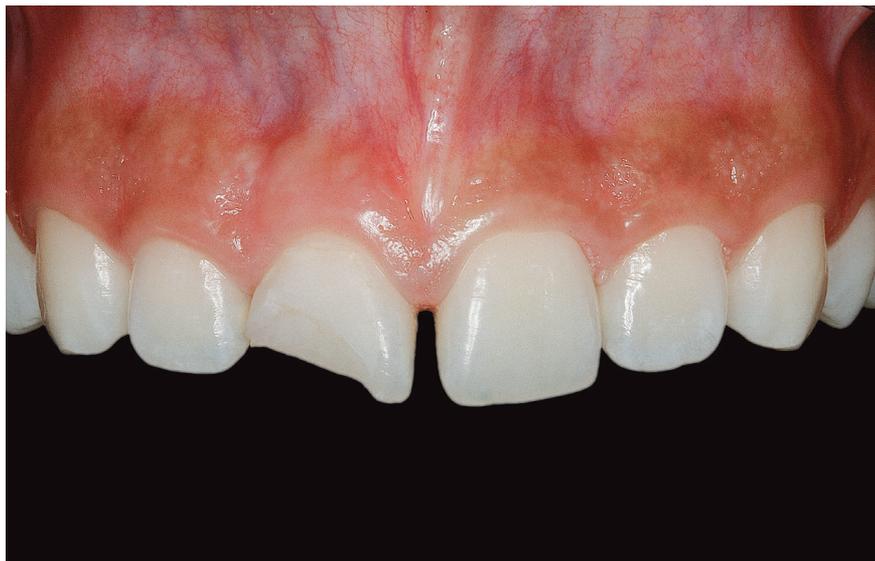
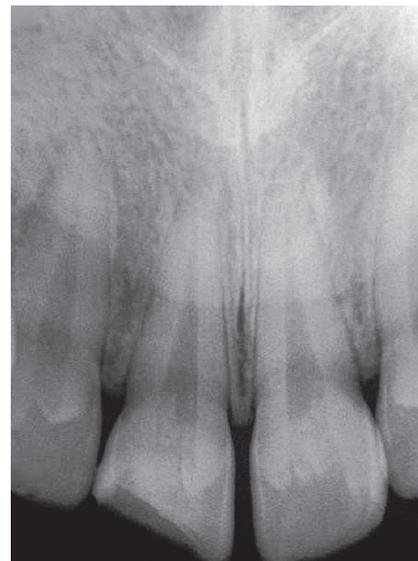
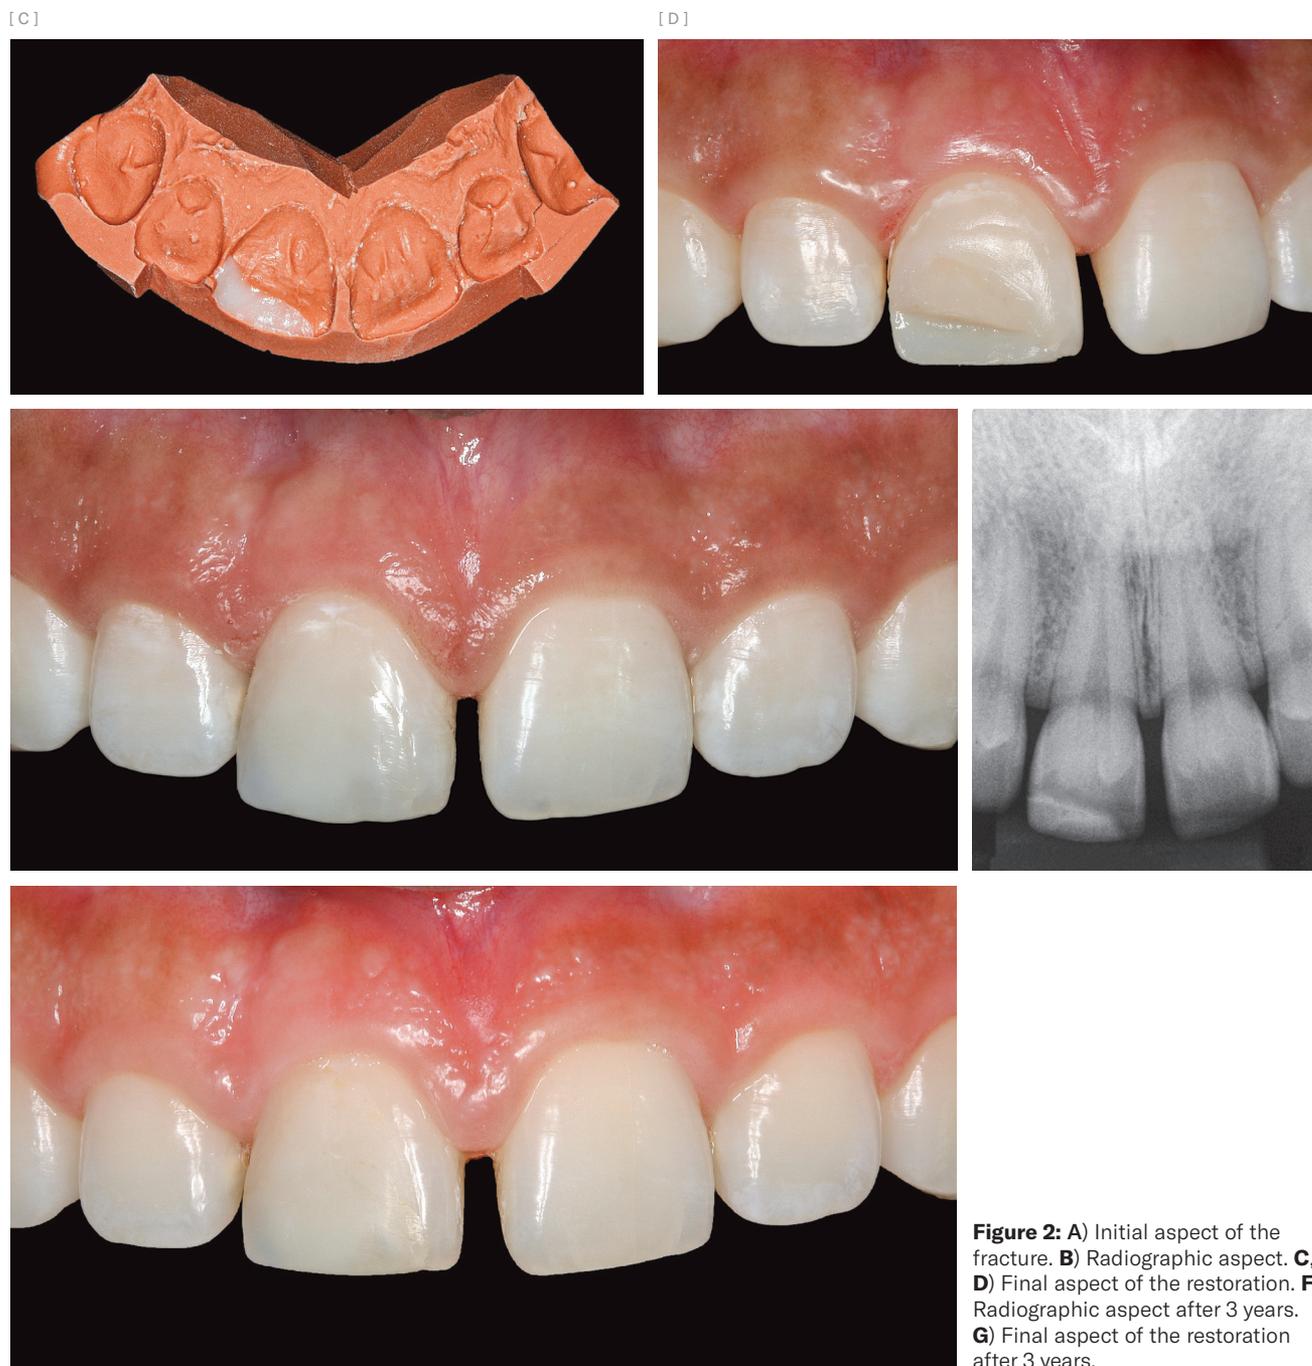
A 18-year-old male visited the dental clinic at our dentistry school institution for evaluation of the right maxillary central incisor (teeth 11). During the anamnesis, the patient reported having suffered a bicycle accident that caused an enamel and dentin oblique fracture in the middle and incisal third of the 11 without involving pulp exposition (Fig 2A). The vitality of the pulp was not compromised, and there was no impaired mobility or lesions in soft tissues. Radiographic observation revealed normal conditions of periodontium and bone structures (Fig 2B). In addition, there was no bevel in the remaining tooth structure.

Figure 2: A) Initial aspect of the fracture. B) Radiographic aspect. C, D) Final aspect of the restoration. E) Final aspect of the restoration. F) Radiographic aspect after 3 years. G) Radiographic aspect after 3 years.

The resin composite used were palatine enamel shade B1 and dentin shade A1 (Amelogen Plus, Ultradent Products, South Jordan, UT, USA). Blue and gray tints (Tetric Color, Ivoclar Vivadent, Schaan, Liechtenstein) were used to modify the incisal resin, improving the aspect of the incisal third of the tooth, and buccal surface was restored with enamel shade B1 (Amelogen Plus, Ultradent Products, South Jordan, UT, USA) (Figs. 2C-E). The patient returned for follow-up visits after 36 months post-treatment (Figs 2F-G).

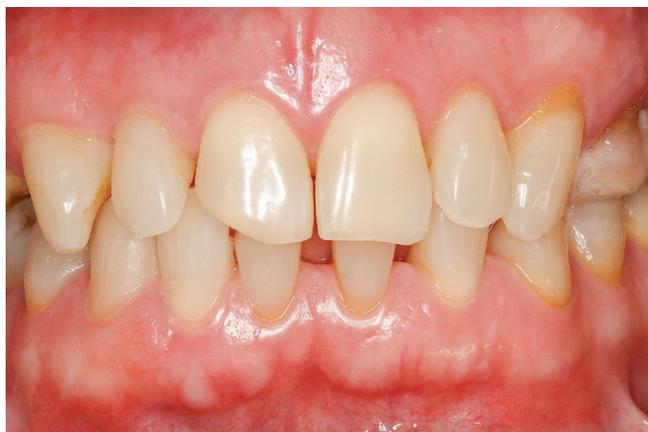
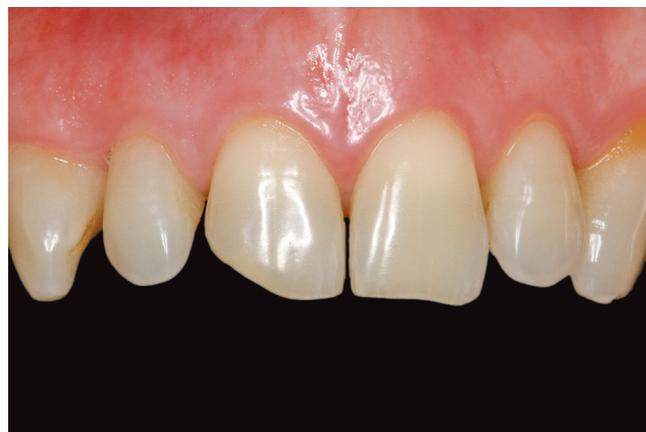
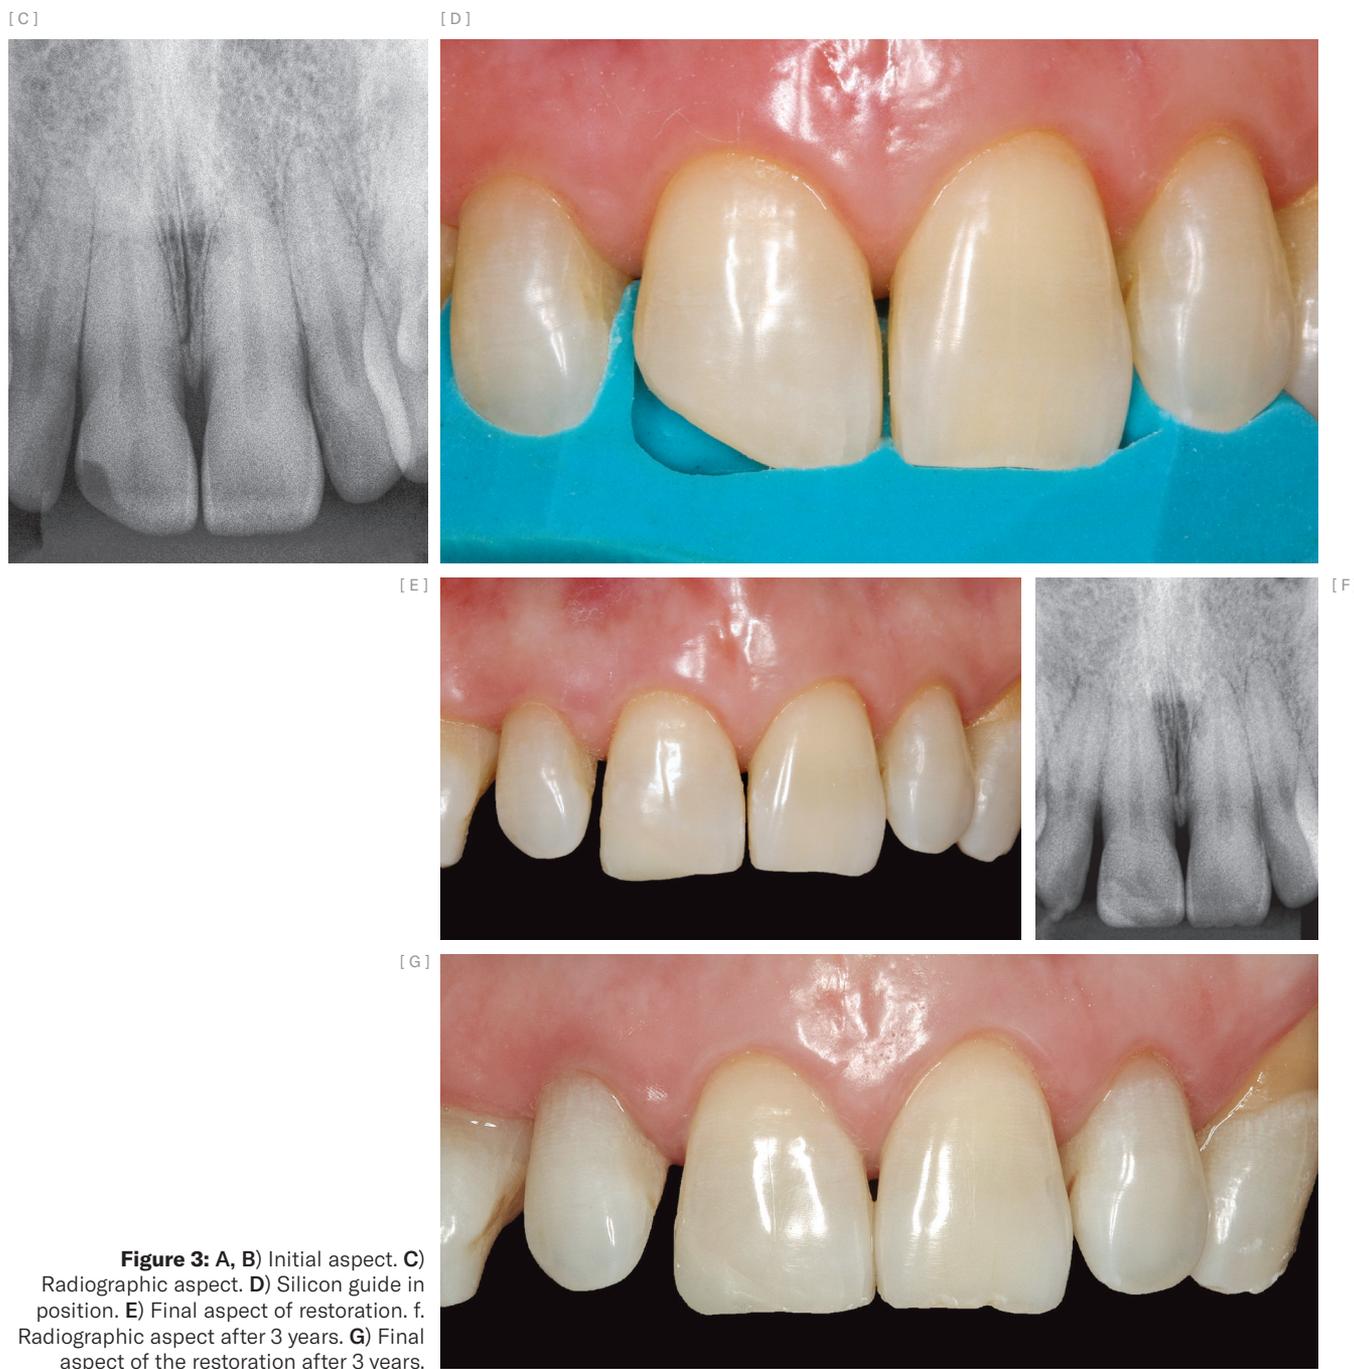
A 46-year-old male patient sought the Dentistry school reporting a fracture in maxillary central incisor (teeth 11). The patient reported that the trauma had occurred approximately 2 days ago and had been caused by a falling during a sport activity (Figs. 3A-B). The tooth had an uncomplicated crown fracture involving enamel and dentin in the mesio-distal direction.

Clinically the teeth revealed no mobility or lesions in soft tissues. Radiographic examination showed no periodontal lesions or bone fractures. For restoration procedures, the selected color of the com-

Figure 3: A, B) Initial aspect. C) Radiographic aspect. D) Silicon guide in position. E) Final aspect of restoration. f. Radiographic aspect after 3 years. G) Final aspect of the restoration after 3 years.

posite resin used was A2 Enamel and C2 Dentin (Amelogen Plus, Ultradent Products, South Jordan, UT, USA) (Figs. 3C-E).

After that, the restorative procedure was evaluated for occlusal interferences and adjusted when necessary. The final polishing was performed using interface Sof-Lex disks (3M ESPE, St. Paul, MN, USA) and a high gloss polishing slurry (Opal L Renfert GmbH, Hilzingen, Germany). Clinical and radiographic examinations were performed for control during the follow-up visits at two and five months after the adhesive restorative procedure until the period of 36 months (Figs. 3F -G).
