Use of technology and calcium silicate cement in the resolution of endodontic retreatment complications: Case report

How to cite: Silva EM, Alcalde MP, Vivan RR, Pomini M, Duarte MAH. Use of technology and calcium silicate cement in the resolution of endodontic retreatment complications: Case report. *Dental Press Endod.* 2020 May-Aug;10(2):86-93. DOI: <https://doi.org/10.14436/2358-2545.10.2.086-093.oar>

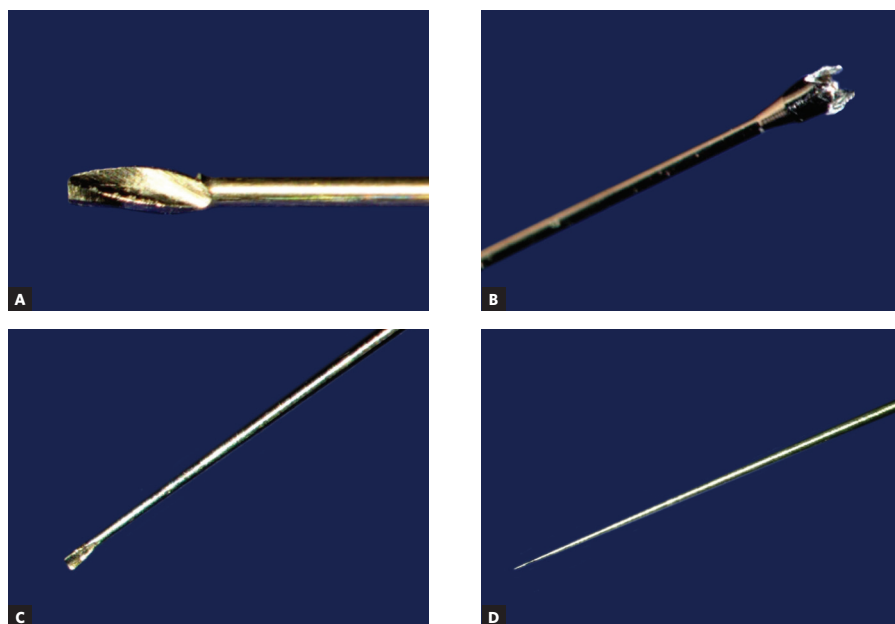
Attempts were made to remove the fragments, starting with the mesial root fragment. Initially, careful widening of the mesiobuccal canal with modified Gates-Glidden # 3 drill (Terauchi file retrieval kit accessories, Dental Cadre, California, USA) was performed (Fig 2A). in order to enlarge the canal and create a larger surface up to the coronal portion of the fragment, allowing better access and visualization of it. In the next step, a micro trephine drill that has inner and outer diameter of 0.45 mm and 0.6 mm respectively (Terauchi file retrieval kit accessories, Dental Cadre, California, USA) (Fig 2B) driven at low counterclockwise rotation was used to create a space around the coronal part of the fragment. After this procedure, the micro spoon type ultrasonic tip (TFRK-6, Dental Cadre, California, USA) (Fig 2C) was used to assist in the creation of a space between the instrument and the root canal wall, allowing a careful wear of the area. Next, a straight ultrasonic

tip (TFRK-S Dental Cadre, California, USA) was used (Fig 2D), which was placed laterally to the fragment, activated with intermittent and short propulsion and recoil movements applied to the fragment in an attempt to dislodge it.

Figure 2. Rotary instruments: **A)** Modified Gates-Glidden III drill. **B)** Microtrepine Drill # 5. **C)** Micro spoon TRFK-6 ultrasonic tip. **D)** TFRK-S straight thin ultrasonic tip.
