Influence of auxiliary lighting, attached to high-speed turbine, in cavity dimensions during replacement of esthetic restoration

How to cite: Oliveira BMB, França M, Lima SK, Zorzi G, Hironaka NGL, Gonçalves B, Pascotto RC. Influence of auxiliary lighting, attached to high-speed turbine, in cavity dimensions during replacement of esthetic restoration. J Clin Dent Res. 2017 Oct-Dec;14(4):86-91.

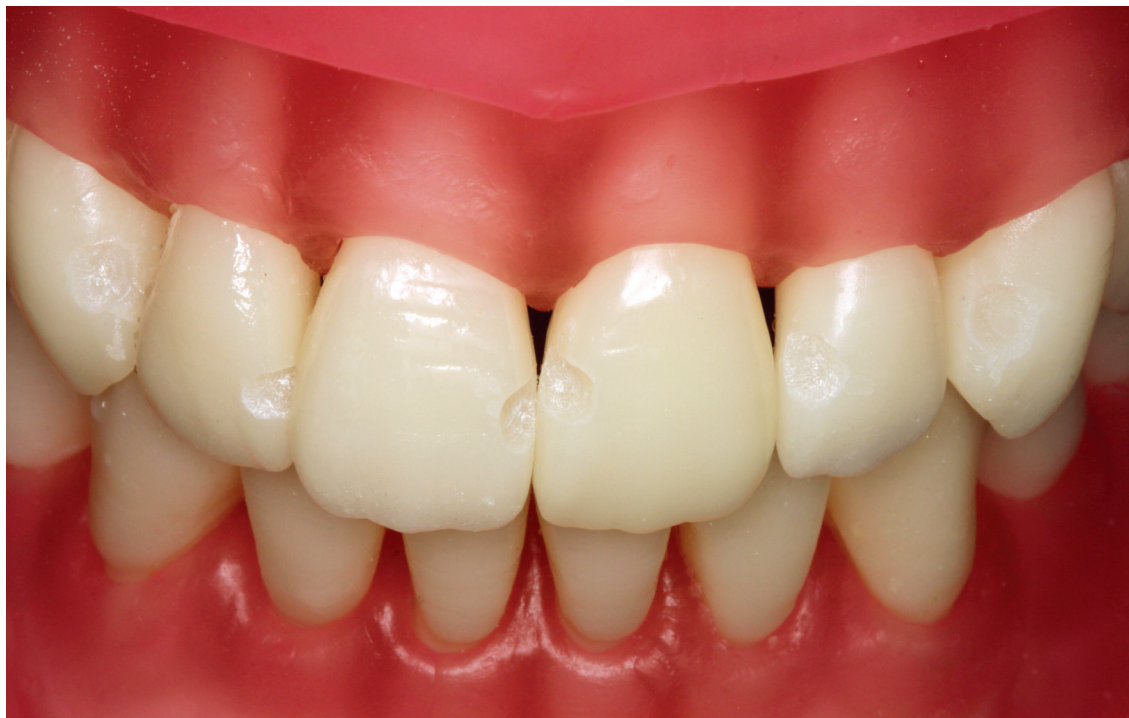
Figure 1: Class III Cavities made in proximal sides of upper anterior teeth.

Thirty-three artificial upper anterior teeth were mounted in a dental model and in a simulator head (Proneu, Rio de Janeiro, RJ). On each tooth, a class III Black cavity was made in the mesial side without making bevel (Fig 1). The cavities were prepared with vestibular access, using spherical diamond edges 1014 (KG Sorensen, Cotia, SP) mounted on a high-speed turbine and refrigerated with air/water spray

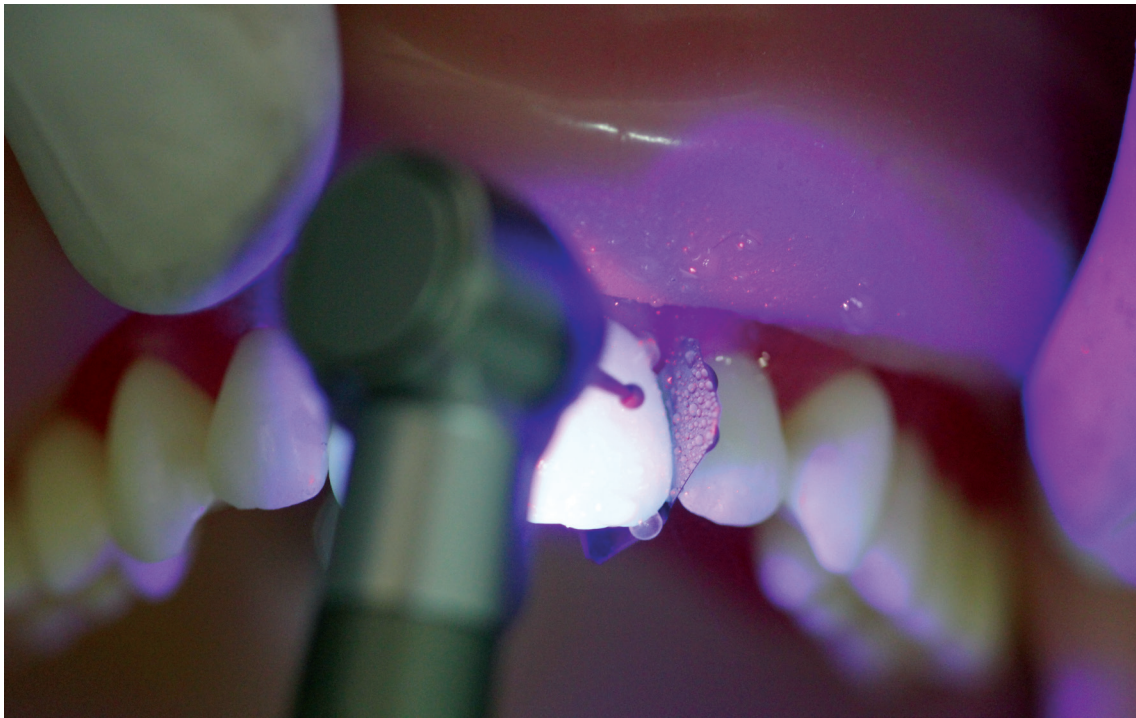
Figure 2: Phase of removal of restorations using the auxiliary ultraviolet light system.

The restorations were removed with spherical diamond edge 1014 mounted on a high-speed turbine with air/water spray. The teeth were divided into three groups (N = 12), in accordance with the way of restorations removal: SL - conventional turbine without light (Aro Gnatus 32, Ribeirão Preto, SP), UV - ultraviolet light turbine attached (Cobra Ultra Vision System®, Gnatus, Ribeirão Preto, SP) - Figure 2 and with LED - white light attached (Cobra System PB Led, Gnatus, Ribeirão Preto, SP).
